P. L. 93-251 SECTION 32 DEMONSTRATION
PROJECTS STUDY

MRD HYDRAULIC LABORATORY SERIES
REPORT NO. 8
PRELIMINARY

PRELIMINARY LABORATORY INVESTIGATION
OF SECTION 32 HARD POINT

U. S. ARMY ENGINEER DISTRICT, OMAHA
MISSOURI RIVER DIVISION, OMAHA
OCTOBER 1978

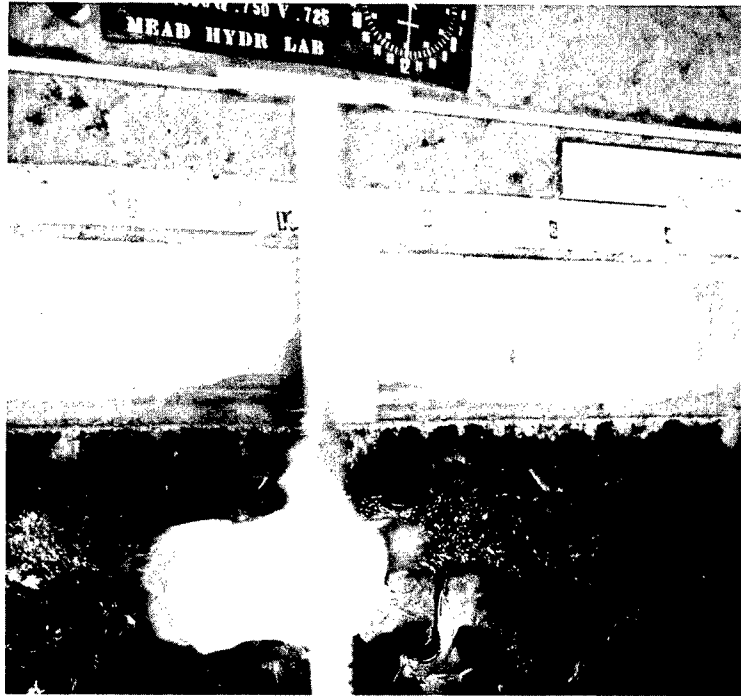
Photograph 1. Leveling test bank by using a male template fixed to a carriage on a rail traverse.

1. The channel bank in the test area was completely rebuilt before each test. It was shaped to the desired configuration by pulling a male template back and forth across the bank material. See photo 1. The template was mounted on a carriage which rolled along a system of uniform elevation railing. This resulted in a berm with a top elevation of 1.500 feet, a top width of 1.6 foot, a length of 20 feet, and a bank slope of 1 vertical to 2 horizontal.

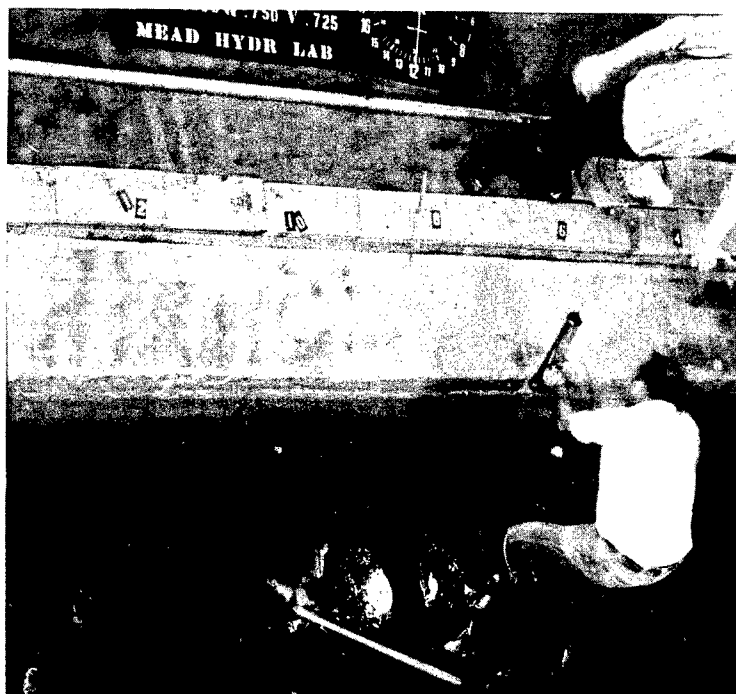
Photograph 2. Excavation of the root trench into the right bank.

2. A trench for the hard point root was then cut in the bank and the rock structure was built by placing the crushed limestone riprap into the trench. See photo 2.

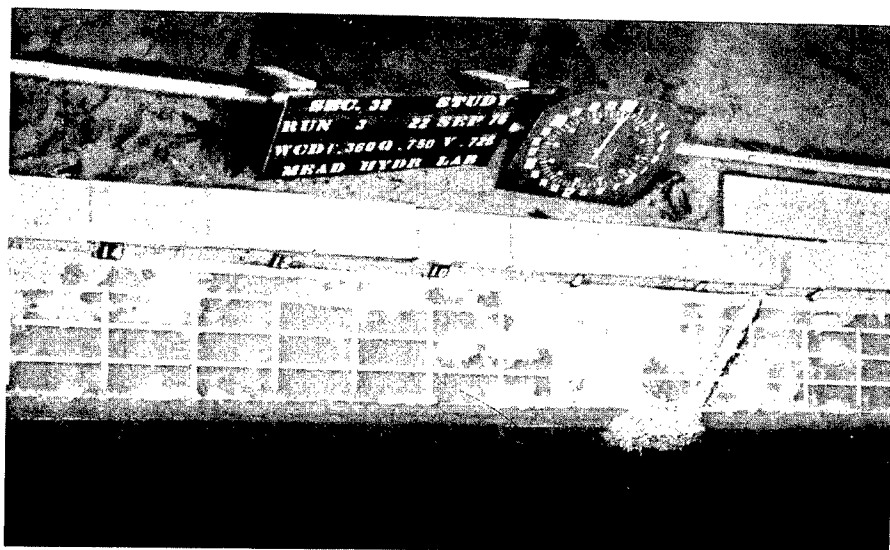
Photograph 6. Test bank arrangement prior to run 3.

The layouts of the different hard point structures are shown on plate 2 and in photographs 6 through 17. For test runs 3, 7, and 8, the hard point structures were constructed out to the edge of the channel bank. For test runs 4, 5, and 6, the hard point structures were extended 0.5 foot further into the channel. This was done in an attempt to determine if this would decrease the amount of bank erosion which occurred downstream from the hard point structures.

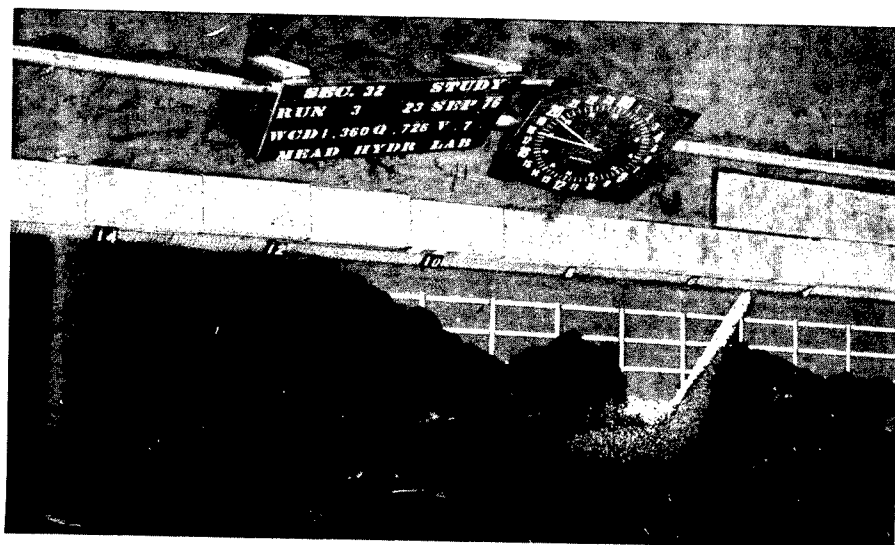
Photograph 7. Resulting channel bed and bank configurations at the end of run 3.

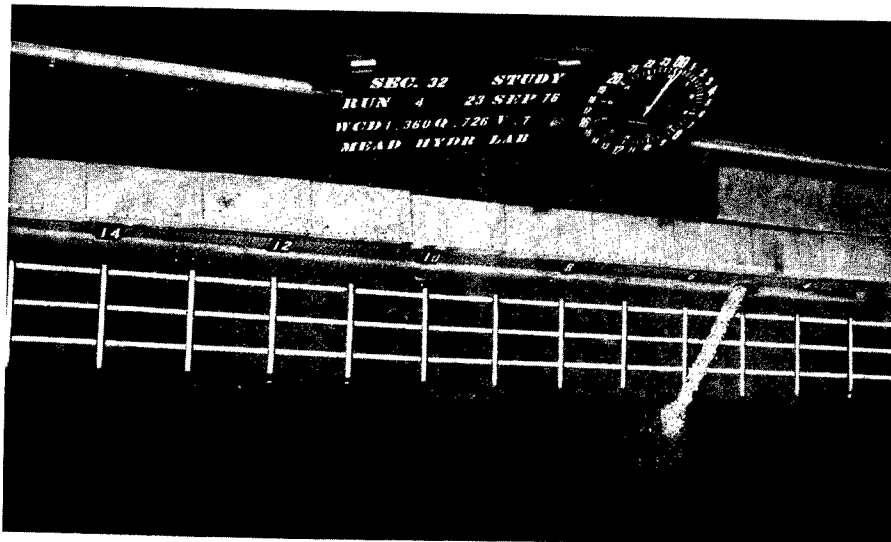
Photograph 8. Test bank arrangement prior to run 4.

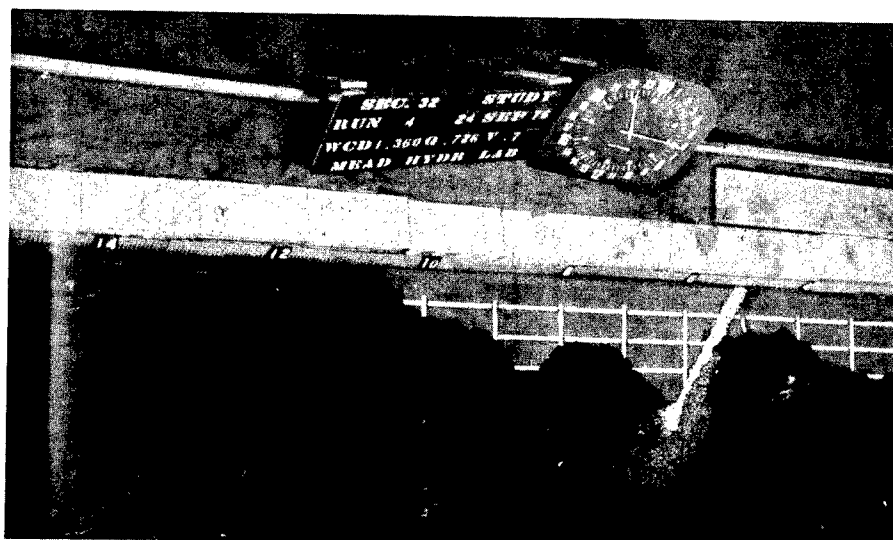
Photograph 9. Resulting channel bed and bank configurations at the end of run 4.

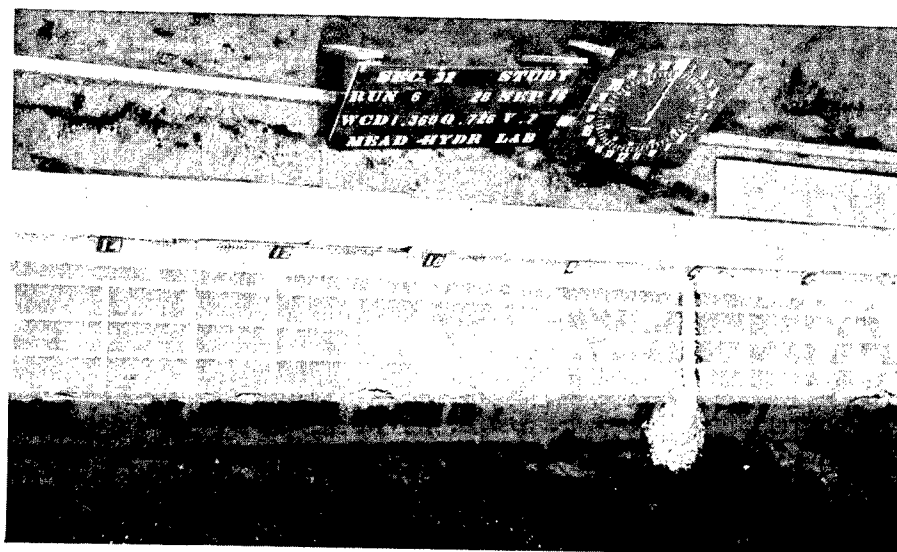
Photograph 12. Test bank arrangement prior to run 6.

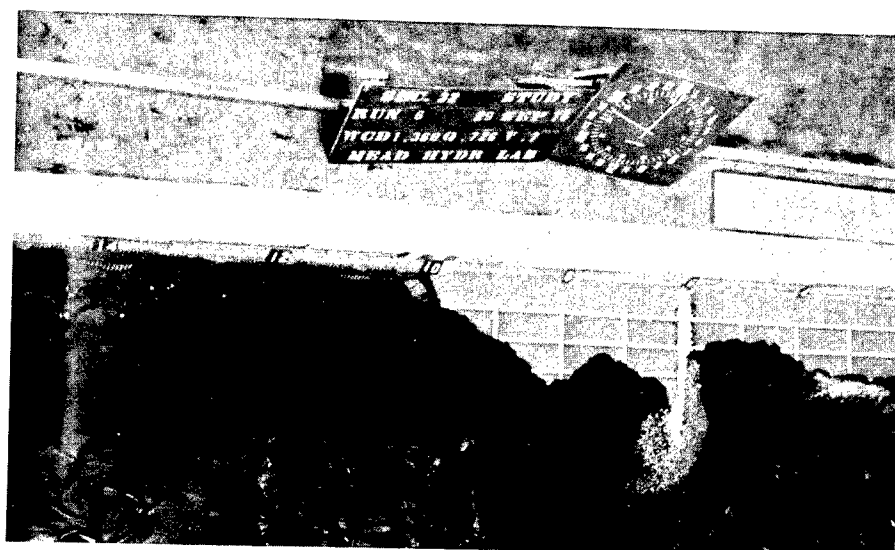
Photograph 13. Resulting channel bed and bank configurations at the end of run 6.

The effect of the 0.5 foot riverward extension of a perpendicular root structure can be seen in the comparison of run 6 with run 7. The extension of the structure in run 6 protects more bank area downstream but uses a greater quantity of rock to armor the upstream slope of the hard point structure. The channel constriction caused by the hard point extension increases the channel velocities and, thus, results in a larger and deeper scour hole.

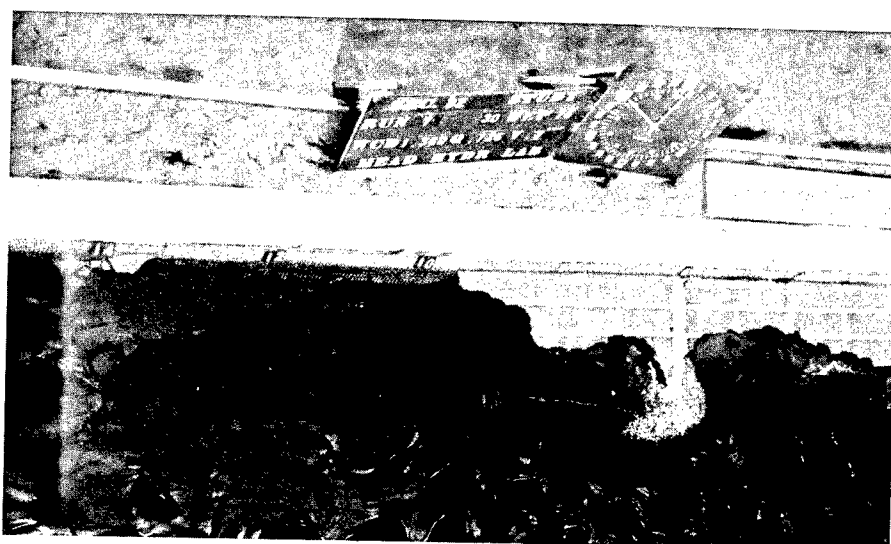
Photograph 15. Resulting channel bed and bank configurations at the end of run 7.

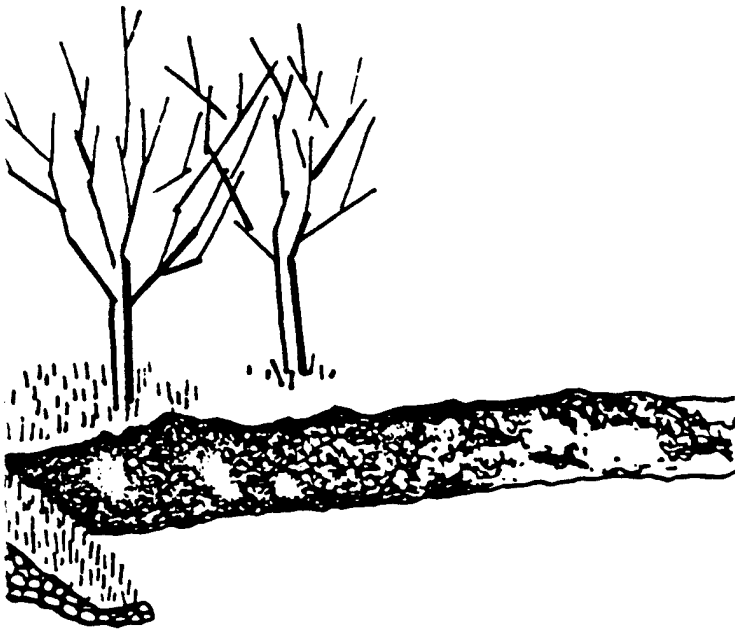
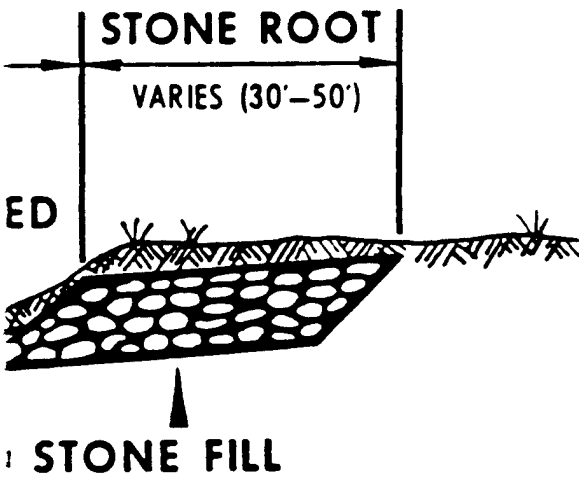
PLATE 1

SECTION 32 DESIGN ST EROSION CONTROL USING H TYPICAL SECTION

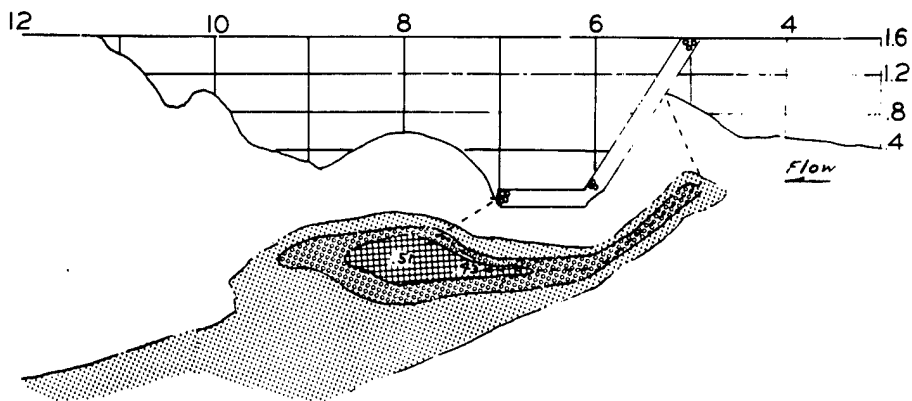
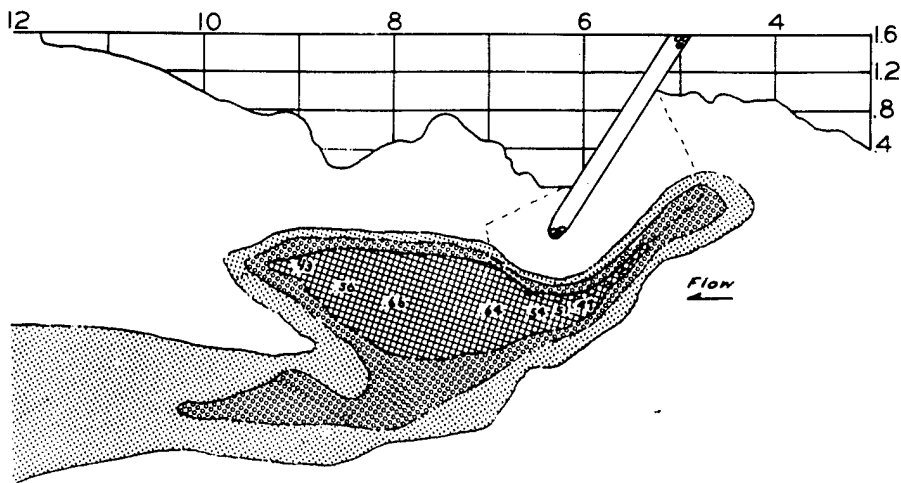
PLATE 2

SECTION
EROSION CONTROL
RESULTS
U.S. ARMY ENGINEER
CORPS OF ENGINEERS

Runs 3 through 8 (plate 2) indicate the amount of bank erosion, which occurred in run 2, was considerably reduced by a hard point structure located at station 6. Runs 4, 5, and 6 had more bank area saved than the other runs.

These runs had structures which extend 0.5 feet further riverward than the other runs. Of these three runs, the structures with angled roots had more bank area protected than the structure whose root was perpendicular to the channel bank. However, the angled root structures had more rock accumulated on the underwater slope than did the perpendicular root structure. See plate 2.

The slow-motion portion of the time-lapse movie indicated that the eddy areas were larger when the structures were placed 0.5 feet further riverward from the channel bank. These structures also had larger and deeper scour holes associated with them. See plate 2. The larger scour holes were created by the increased channel velocities caused by the constriction of the channel from the longer hard point structures. These longer structures had more area of hard point structure exposed to the flow in the channel and, consequently, used a larger amount of riprap to protect the underwater slope. See plate 2. Plots of scour hole lengths, widths, and depths downstream from the ends of the hard point structures are shown on plate 3. The bank erosion line and scour hole angles are also shown on plate 3.

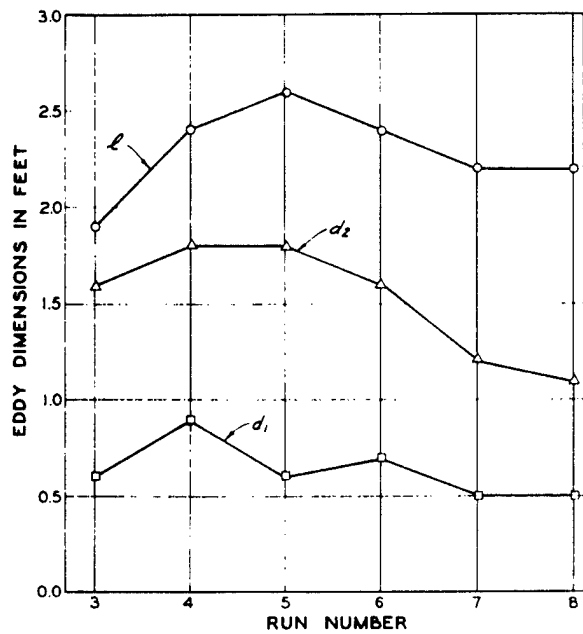
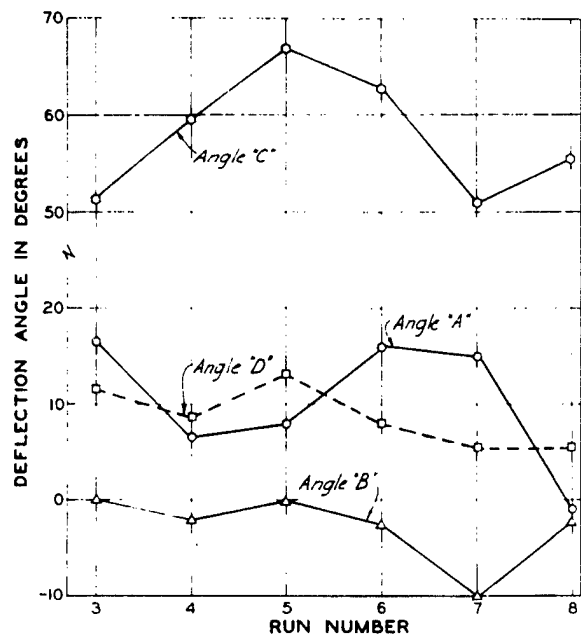
SCOUR HOLE DIMENSIONS IN FEET

SECTION 32 DESIGN STUDY
EROSION CONTROL USING HARD POINTS
 STRUCTURE EFFECTS ON LOCAL EROSION
 U.S. ARMY ENGINEER DISTRICT, OMAHA
 CORPS OF ENGINEERS OMAHA, NEBRASKA
 OCT. 1978

The channel maps are contour charts of the channel bed. Reproductions of the channel maps are not shown in this report. These contour charts showed the general channel characteristics of size and shape of bed scour and the structure effects on local erosion. The scour hole contour maps were extracted from the channel maps to show local effects of the hard point structures. See plate 2. The data which were extracted from the scour hole contour maps were plotted on graphs so as to detect changes and evaluate trends associated with the different structure variations. See plate 3.
